TECHNICAL SERVICE BULLETIN

TSB-OT-0019 REV1

Date: April 05, 2022
To: Internal, Sales, Distribution, and Sales Representatives
From: Jimmy Trusty - Product Specialist
Subject: Revision - 5-Ton Rooftops DFG/DFC Missing Valve Cores in Pressure Switches

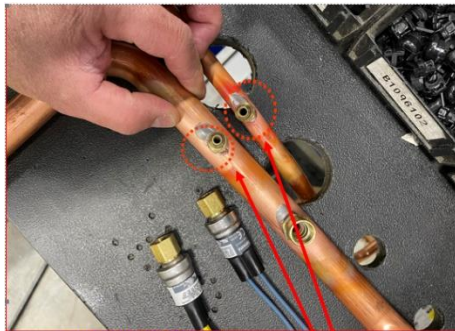
It has come to our attention that the new 1- and 3-phase, 5-ton gas/electric and air conditioner rooftop units (RTU), models DFG and DFC, are missing the valve cores in the low-pressure and high-pressure switch assemblies (see Image 1 below).

Image 1
Valve Core Omitted

All 5-ton (DFG/C060*) RTUs, with serial numbers up to 2202235971, should not be sold or installed until the rework is completed. It is strongly recommended that all distributors promptly contact and inform any customers that have purchased and/or installed any of these units of the required rework by way of this bulletin.

A valve core or tee must be installed per the instructions below using kit CPSKT01. Failure to follow these instructions could result in injury and complete loss of charge.
