SUBJECT: **COMMERCIAL SPLIT SYSTEM (DAX) TRANSFORMER POSSIBLE INCORRECT WIRING**

TSB D-LC-0035

Date: Date, 2023
To: Internal, Sales, Distribution, and Sales Representatives
From: Technical Service Department
Subject: **Commercial Split System (DAX) Transformer Possible Incorrect Wiring**

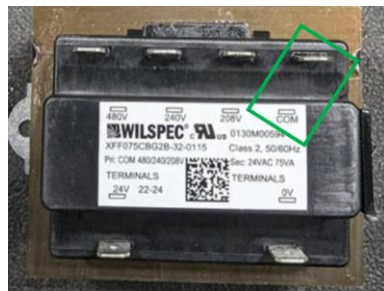
We are providing this notification that there is the possibility when the Wilspec transformer was used in the production of the commercial split system DAX090 and DAX120 models, it could have been wired incorrectly. If so, this could cause low secondary voltage resulting in chattering contactors or contactors not closing.

If you are experiencing low secondary voltage on units manufactured **prior to serial number 2308370481**, check the connection points on the line side of the transformer to ensure that the "black" lead is on the common terminal, and the "Orange" lead is on the desired incoming line voltage terminal. See image of transformers below for COM terminal locations.

Verify Transformers are terminated correctly.
