Document **601-00004-107** Number:

Title: EX5000 MFD Release 8.2.2 Software Upgrade

Revision: 04

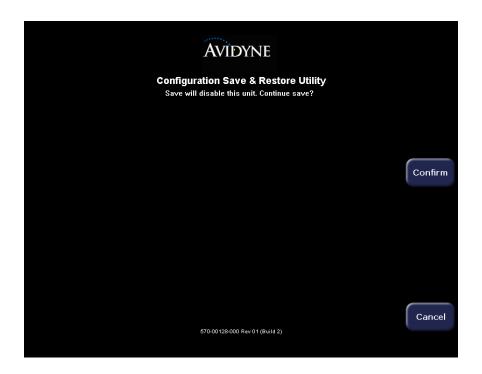
5. _____ After "Save" is selected, a final confirmation must be made that a Save is desired. The following confirmation screen (or similar) will be displayed:

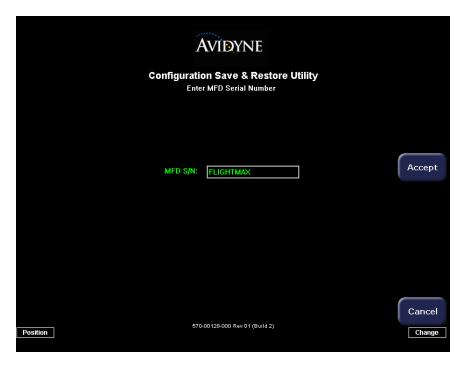
If a serial number entry is required, the utility will display a screen like:

Use the knobs to enter the serial number into the text box as shown that was recorded above. The serial number must contain eight digits. In the case where the MFD serial number contains only four digits such as serial number 1652 enter four preceding zeros so that the serial number entered contains exactly eight digits. A MFD with serial number 1652 would be entered as 00001652. Failure to use a serial number eight digits in length will prevent the loading of future CMAX chart updates.
