TECHNICAL INFORMATION COMMUNICATION

Number: TIC2019-0015

Title: Vane Axial Troubleshooting Procedure

All Vane Axial Electro Mechanical Units

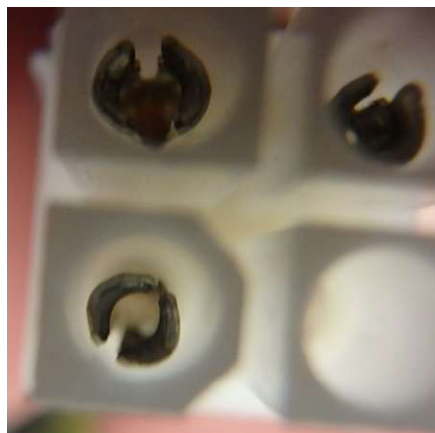
Observed Field Failures

A field practice of probing the connectors with the electric meter probes could possibly damage the connectors and increase the risk of erratic operation of the Vane Axial Fan. The meter probes may be too large and cause the connector to spread out and not provide a good connection.

The Video provides an accurate and less evasive technique in troubleshooting the connections. Thus maintaining the reliability of the components.
